# Tasks Aren't Always As Simple As They Seem

By AM2(AW) Randy Wade

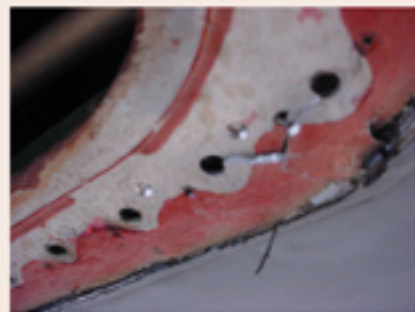
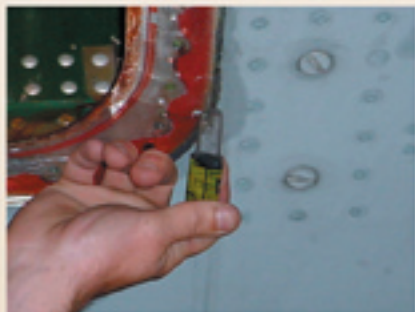
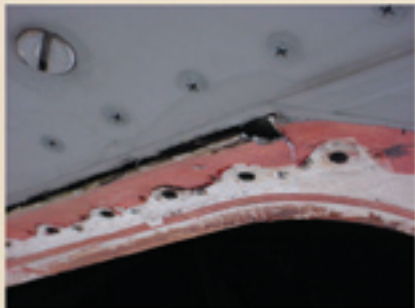
than expected and inadvertently punctured the edge of the inner lip. Unaware of the lip puncture, he proceeded to pull down on the tank lid to pry it loose. We heard a loud “pop.” As the radius of the inner tank lip gave way, it ripped the lip from one corner to the other. After realizing what just had happened, we went back to the shop to tell our CDI about the damage.

Maintenance control and QA were notified of the situation, and they investigated the incident. Once the tank lid was removed, QA, maintenance control, and a naval-aviation depot determined that the problem had originated during earlier maintenance on the tank lid. Someone had applied an excessive amount of topcoat and had sealed the lid to the lip. That maintenance lapse made it difficult to remove the lid. Maintenance publications do not give instructions on how to remove lids; it directs only to remove them. Two pry points on the leading edge of fuel-cell panels are marked with notches cut in the corners of the panel, but this fact is not described in the procedures.

Panels easily can be damaged when the wrong procedures are used or when “the book” doesn't give clear steps.

Had pressure been applied on this area, damage would have been avoided. The final cost to repair the wing plank was \$14,000, and the fix required 52 days and 932 man-hours to complete. We learned several lessons, but these two critical ones stand out: Not following proper maintenance procedures can lead to costly maintenance repairs, and, if a procedure is not clearly stated or if you're unsure of the proper procedure, use the knowledge and experience of the people around you.
